SLEEPER DAM ME-00014

PHASE I INSPECTION REPORT NATIONAL DAM INSPECTION PROGRAM

SABATTUS
ANDROSCOGGIN COUNTY, MAINE

March 27, 1979 (Field Inspection)

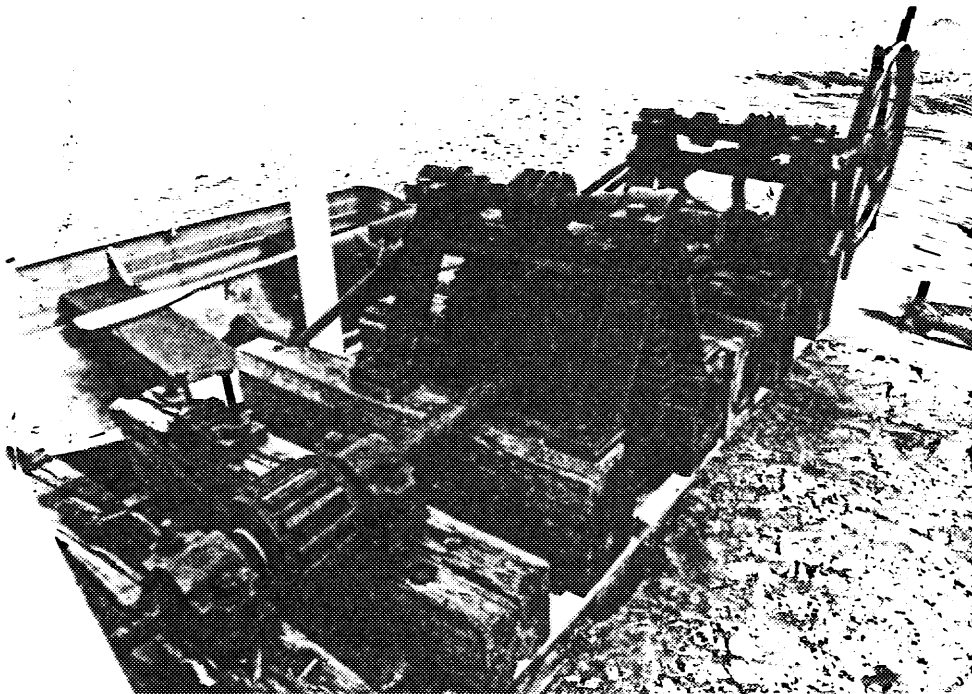
4

c. Appurtenant Structures. Some leakage was occurring around the control outlet gates. The hoisting equipment appeared to be in fair condition but the lifting stems on the gates have been broken, rendering the gates inoperable.

- b. Operating and Control Gates. The gates consist of two vertical lift timber gates. The lifting stems on the gates have been broken and the gates are presently inoperable (see Photo #4). The hoisting equipment with the exception of the lifting stems appears to be in fair to good condition.

GATE OPERATING EQUIPMENT

- (1) Repair of spalled concrete surfaces.
- (2) Repair of the outlet gates and operating equipment to return these gates to operable condition.
- (3) Clearing of trees and brush from the left abutment to provide better flow characteristics and to lessen deterioration of the bedrock surface and mortar-laid masonry fill.
- (4) Provide around-the-clock surveillance during periods of anticipated high runoff.
- (5) Develop a formal warning system and implement its use in the event of an emergency.
- (6) Have inspections of the dam made by Registered Professional Engineers once every year.

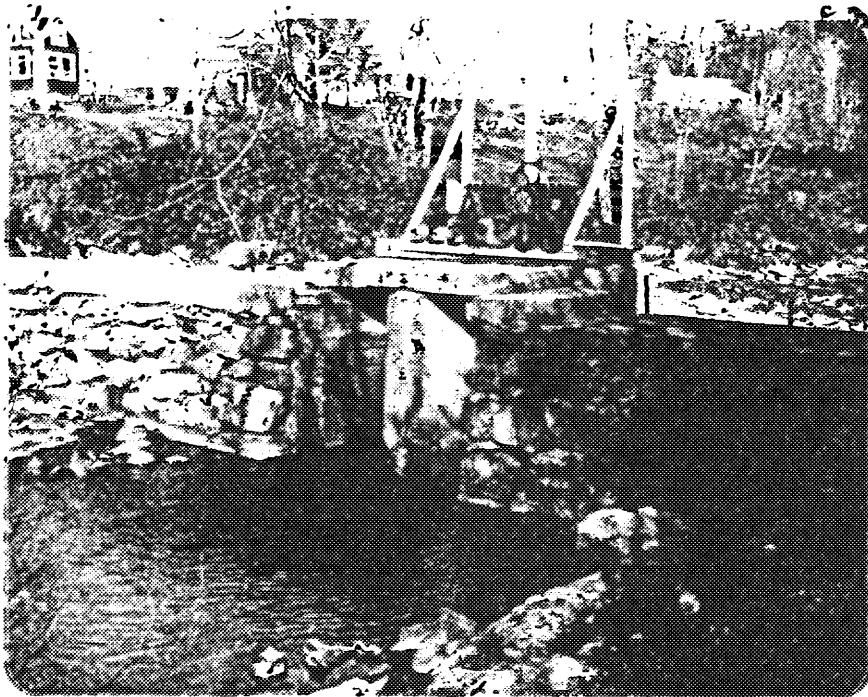
6

- c. Conduits, Sluices and Water Passages. The interior surfaces of the sluiceway appear to be in generally good condition. Substantial spalling and erosion has occurred on the lower portion of the sidewalls and the central pier (see Photos #6, 7 and 8). No serious leakage is occurring into the outlet conduit.

DOWNSTREAM FACE

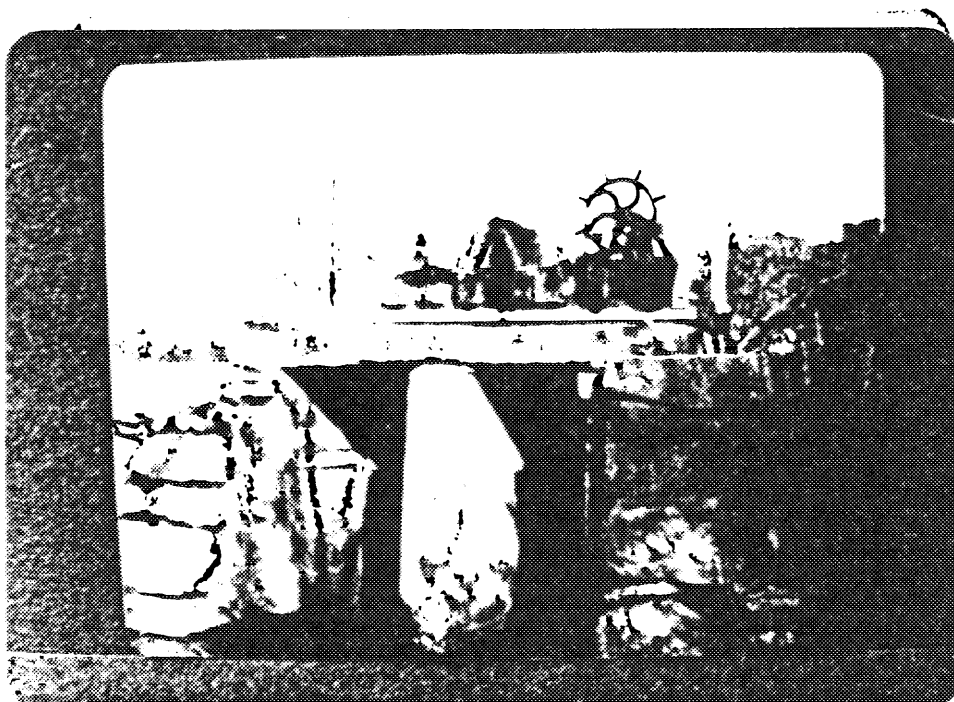
7

- (3) The concrete sidewalls and center pier in the outlet works are badly spalled.
 - (4) There is not adequate access to the control outlet gateworks during high flow.

GATED OUTLET SLUICE

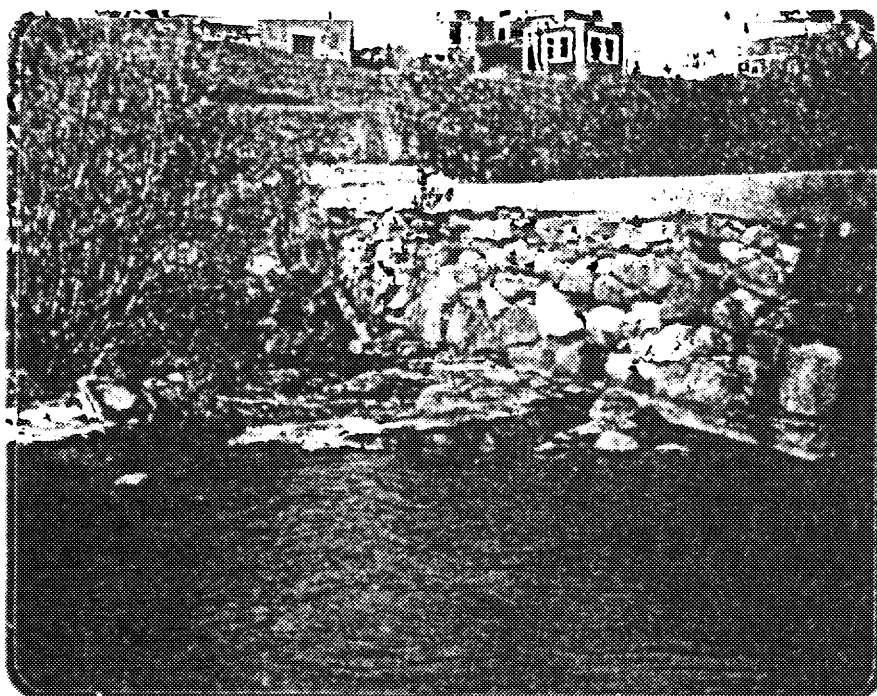
10

DOWNSTREAM FACE OF WESTERLY SPILLWAY
NOTE BRUSH IN DOWNSTREAM CHANNEL

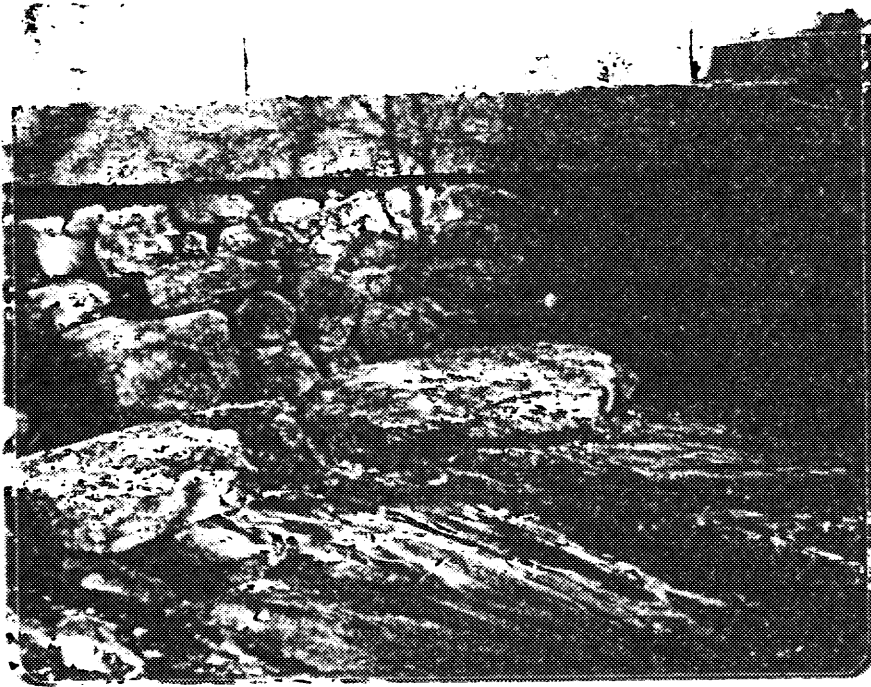
11

- (a) The masonry in the downstream face appears loose in many areas. Voids exist in some areas where the stones have tumbled from the face (see Photo #11).

- (1) The stone masonry which supports the spillway crest is loose and some stones have been displaced.
 - (2) The control outlet gate lifting stems are broken and are therefore inoperable.

DOWNSTREAM FACE - LEFT SPILLWAY
NOTE ERODED AREA

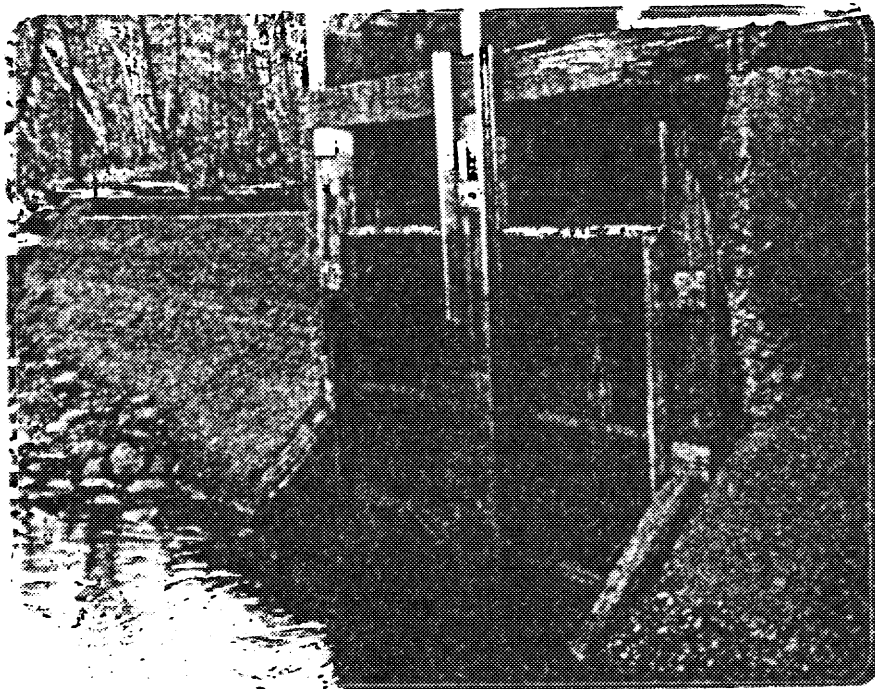
12

GATED OUTLET - VIEW FROM UPSTREAM
NOTE DETERIORATION OF CONCRETE
